# Bone Contusion Patterns of the Knee at MR Imaging: Footprint of the Mechanism of Injury<sup>1</sup>

**RadioGraphics 2000;** 20:S135-S151

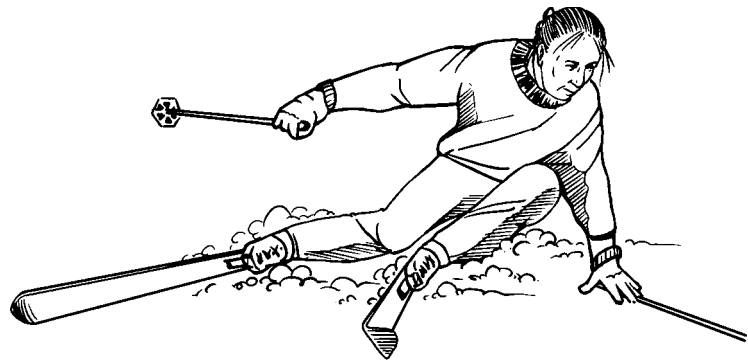
**Figure 1.** Pivot shift injury. (a) Drawing shows a skier with a right knee pivot shift injury (knee valgus, femur internally rotated), a non-contact injury that results when decelerational-rotational-valgus stress is applied to the knee while it is in various states of flexion. (b) Drawing shows that, with the foot planted, the combination of valgus stress on the knee and internal rotation of the femur results in disruption of the ACL. After disruption of the ACL, the tibia is free to sublux anteriorly relative to the femur. This movement results in the impaction of the lateral femoral condyle against the posterolateral tibial plateau. Cross-hatching indicates areas of bone contusion. The degree of flexion of the knee at injury determines the exact location of the lateral femoral condyle contusion.

The pivot shift injury is a noncontact injury commonly seen in skiers or American football players. This injury occurs when a valgus load is applied to the knee in various states of flexion combined with external rotation of the tibia or

internal rotation of the femur (Fig 1). This type of injury usually occurs with maneuvers such as rapid deceleration and simultaneous direction change. These maneuvers load the anterior cruciate ligament (ACL) and can result in its rupture (6,7). Once the ACL is disrupted, anterior subluxation of the tibia relative to the femur occurs, which results in impaction of the lateral femoral condyle against the posterolateral margin of the lateral tibial plateau (8–10).

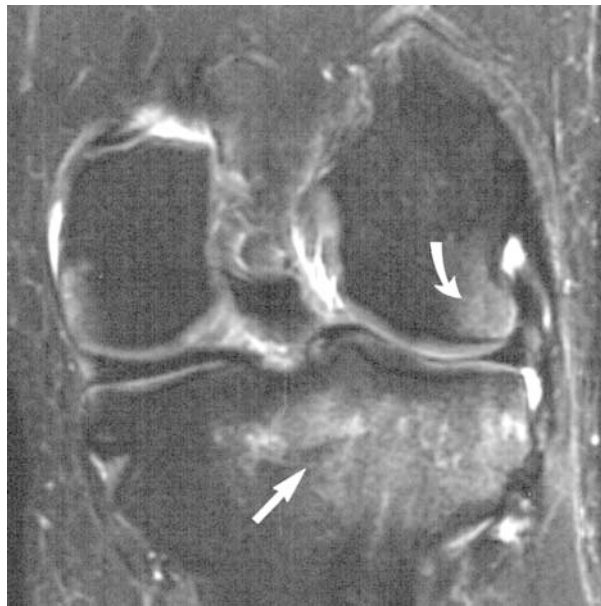
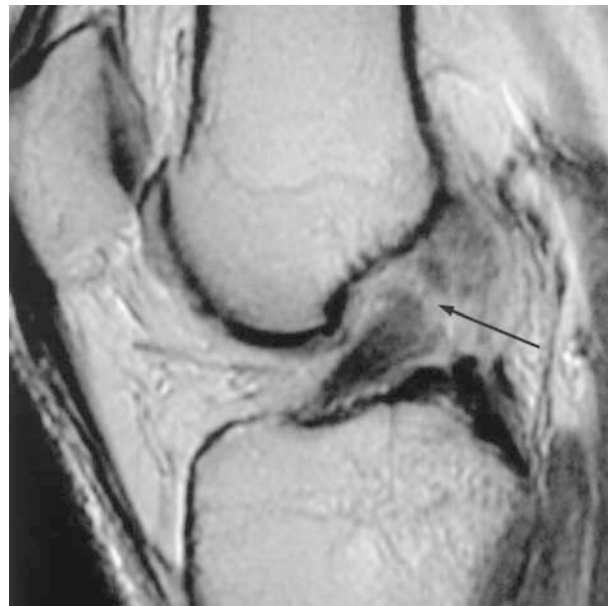
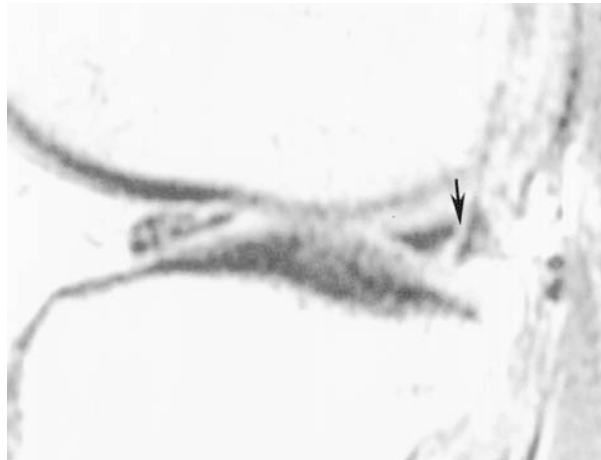
**Figure 2.** Pivot shift injury in a 33-year-old woman who disrupted her ACL in a skiing accident. **(a)** Coronal T2-weighted fast spin-echo (SE) MR image obtained with fat saturation demonstrates the classic bone marrow edema pattern resulting from pivot shift injury of the knee. Extensive contusion is present in the posterolateral tibial plateau (straight arrow) and, to a lesser degree, the lateral femoral condyle (curved arrow). **(b)** Sagittal proton-density-weighted MR image shows an amorphous-appearing ACL with an area of signal intensity similar to that of fluid extending completely through it (arrow), a finding that is consistent with complete disruption. **(c)** Sagittal T1-weighted SE MR image demonstrates an associated vertical tear (arrow) of the posterior horn of the lateral meniscus. A tear of the anterior horn is also present.

The resulting bone contusion pattern involves the posterior aspect of the lateral tibial plateau and the midportion of the lateral femoral condyle near the condylopatellar sulcus (Fig 2). The

and morphology of the ligament. After an acute injury, high T2 signal intensity traverses the ligament (Fig 2a); the ACL appears indistinct and may demonstrate an abnormal slope.

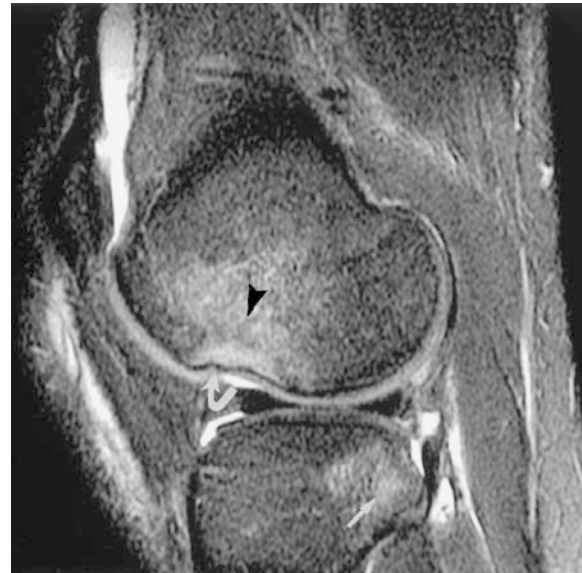
**Figure 3.** Relationship between degree of flexion of the knee at injury and location of the femoral condyle edema in pivot shift injury. **(a, b)** Sagittal T1-weighted **(a)** and T2-weighted **(b)** fast SE MR images (fat saturation used in **b**) of a 15-year-old boy after a pivot shift injury. The knee was in a state of moderate flexion at injury, resulting in a posteriorly located contusion of the femoral condyle (long arrow). The bone contusion also involves the posterior aspect of the lateral tibial plateau (short arrow).

**(c)** Sagittal T2-weighted fast SE MR image obtained with fat saturation of a 28-year-old man after pivot shift injury. The knee was in a state of minimal flexion at injury, and, as a result, the bone contusion (arrowhead) is located more anteriorly on the lateral femoral condyle. There is deepening of the lateral femoral sulcus (which is usually less than 2.0 mm deep) (curved arrow) secondary to impaction on the posterior lateral tibial plateau. The deep femoral sulcus sign has a high specificity for ACL disruption (11). Bone contusion also involves the posterior lateral tibial plateau (straight arrow).

exact location of the lateral femoral condyle injury depends on the degree of flexion of the knee at injury. Increasing degrees of flexion result in a more posteriorly located bone bruise, whereas less flexion results in a more anteriorly located edema pattern (Fig 3). Another recently described bone contusion pattern associated with the pivot shift injury is edema within the posterior lip of the medial tibial plateau. This pattern is thought to result from contrecoup forces in the medial compartment at the resolution of the forced valgus forces (12) (Fig 4).

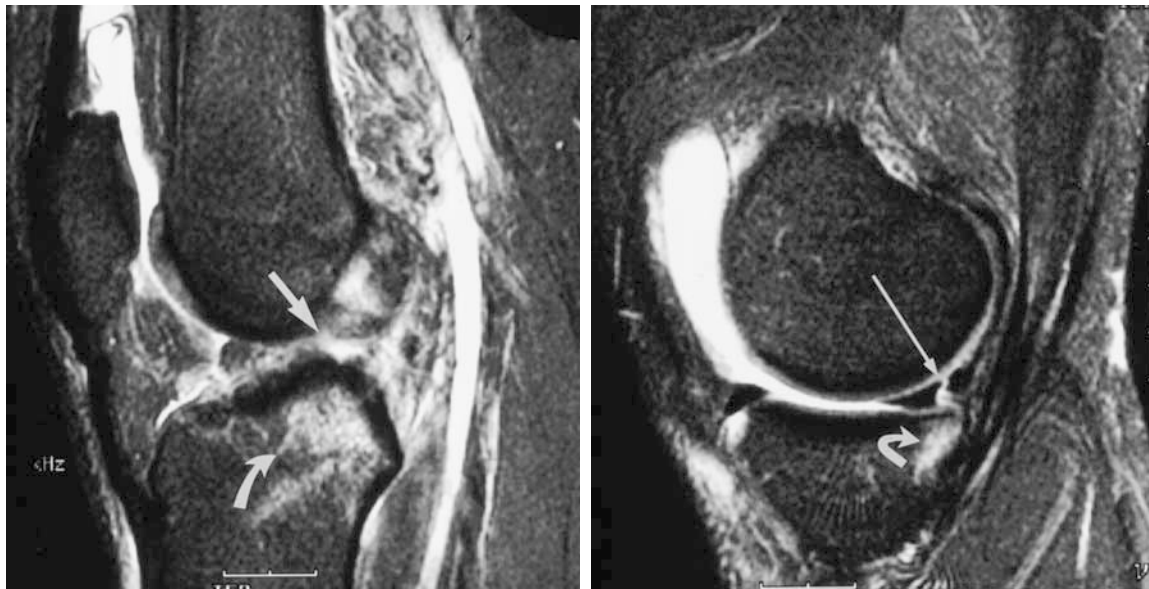
**Figure 4.** Bone contusion involving the posterior lip of the medial tibial plateau in a 33-year-old man who sustained a pivot shift injury. Oblique sagittal T2-weighted fast SE images obtained with fat saturation show complete disruption of the ACL (straight arrow in **a**), edema (curved arrow in **a**) in the posterior aspect of the midline tibial plateau, and edema (curved arrow in **b**) in the posterior lip of the medial tibial plateau. This particular edema pattern is thought to result from contrecoup forces after a pivot shift injury and has a high specificity for ACL disruption. A vertical tear (straight arrow in **b**) through the peripheral aspect of the posterior horn of the medial meniscus is also seen. Scale is in centimeters.

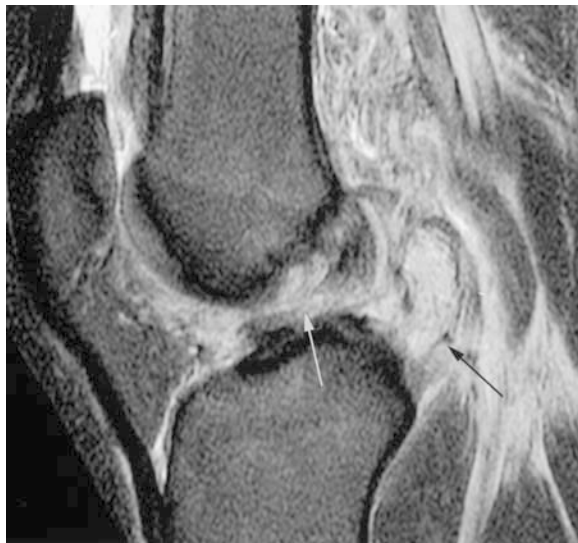
**Figure 5.** Posterior capsule disruption in a 21-year-old man who sustained a severe pivot shift injury while playing football. On a sagittal T2-weighted fast SE MR image, the ACL appears completely disrupted and amorphous. An area of high signal intensity (white arrow) completely traverses the ligament. There is complete disruption of the posterior lateral capsule (black arrow) and extensive surrounding soft-tissue edema.

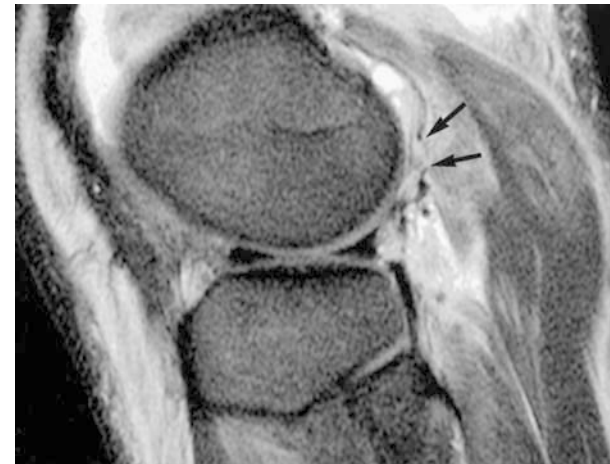
**Figure 12.** Posterior capsule disruption after a severe hyperextension injury in three separate patients. **(a)** Sagittal T2-weighted fast SE MR image shows edema (white arrows) in the anterior aspect of the distal femur and proximal tibia. The edema in the distal femur is too proximal to represent a kissing contusion secondary to hyperextension and probably occurred secondary to direct impact forces. The posterior lateral joint capsule is completely disrupted, as noted by complete absence of the posterior capsule (long black arrow) and extensive surrounding edema. The tendon of the lateral head of the gastrocnemius (short black arrow) was also disrupted. **(b)** Sagittal T2-weighted fast SE MR image demonstrates disruption of the posterior joint capsule (arrow) with extensive edema in the posterior soft tissues. The ACL and PCL were also disrupted (not shown). **(c)** On a sagittal T2-weighted fast SE MR image, discontinuity of the posterior joint capsule is seen as discontinuity of the line representing the posterior capsule (arrows). Note the extensive surrounding soft-tissue edema.

Depending on the amount of force applied, associated soft-tissue abnormalities may include injury to either the ACL (Fig 10) or PCL and a meniscal injury (15). MR imaging characteristics of ACL or PCL injury are similar to those described earlier. If a substantial force is applied, dislocation of the knee may occur (16–18), along with injury of the popliteal neurovascular structures (19) (Fig 11), complete disruption of the posterolateral complex (20) (Fig 12), and, possibly, gastrocnemius injury.

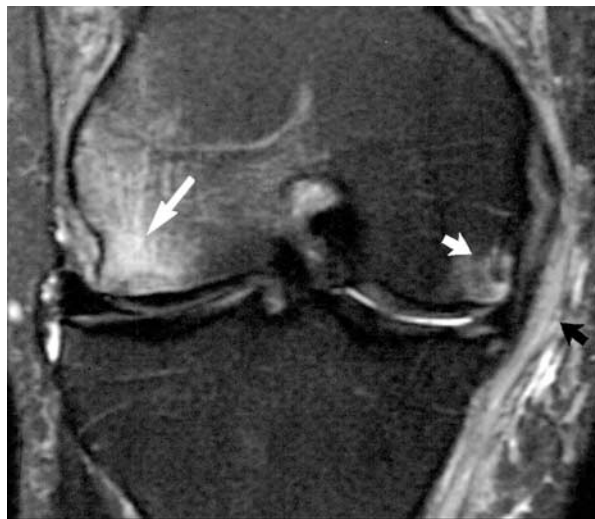
14.

**Figures 14, 15.** (14) Clip injury sustained by a 21-year-old man while playing football. Coronal T2-weighted fast SE MR image obtained with fat saturation shows a large area of contusion involving the lateral femoral condyle (long white arrow). Minimal edema is noted within the medial femoral condyle (short white arrow). The edema is distal to the attachment site of the MCL and is likely secondary to impaction. The MCL is partially disrupted (black arrow). (15) MCL sprain. Coronal T2-weighted fast SE MR image obtained with fat saturation demonstrates an intact MCL (curved arrow) with superficial edema (straight arrows), findings consistent with a grade I sprain.

tact. A partial tear of the MCL is a grade II injury (Fig 14) and can be seen on MR images as a partial discontinuity of the fibers with adjacent areas of increased signal intensity on T2-weighted images in the setting of acute injury; some fibers will remain intact. Complete disruption is a

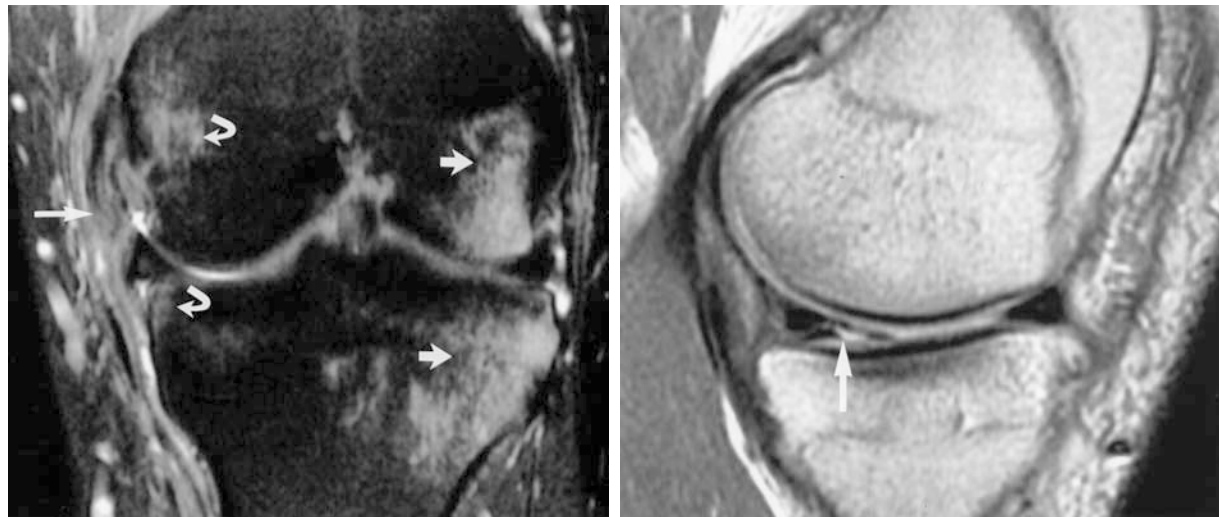
**Figure 16.** O'Donoghue triad resulting from a severe clip injury sustained by a 23-year-old man while playing football. **(a)** Coronal T2-weighted fast SE MR image reveals edema (short straight arrows) in the lateral femoral condyle and lateral tibial plateau secondary to direct contusion. Minimal edema (curved arrows) is noted in the medial femoral condyle and medial tibial plateau secondary to avulsive forces. There is complete disruption of the MCL (long straight arrow). **(b)** Sagittal proton-density-weighted SE MR image reveals a complex tear (arrow) involving the posterior horn of the medial meniscus. **(c)** Sagittal proton-density-weighted SE MR image demonstrates complete disruption (arrow) of the proximal fibers of the ACL.

grade III injury (Fig 16a) and can be seen as complete discontinuity of the MCL fibers (25,26), with extensive surrounding high signal intensity on T2-weighted images in acute cases. Increasing degrees of flexion of the knee at injury may result in disruption of the ACL and a tear of the medial meniscus. This extensive injury combination is better known as the O'Donoghue triad (Fig 16).

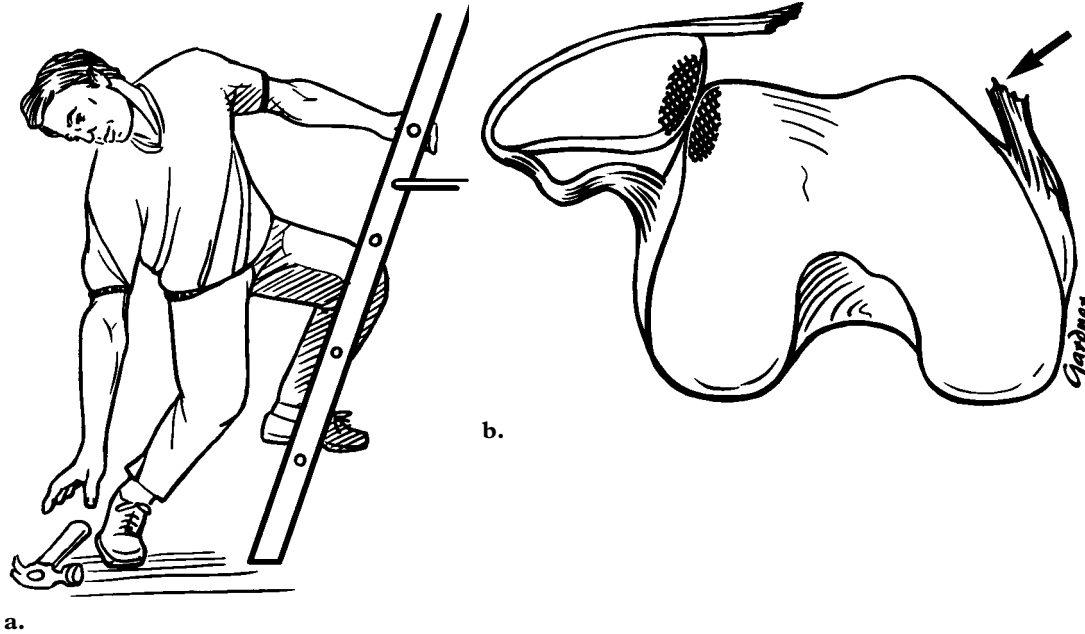
**Figure 17.** Lateral patellar dislocation. (a) Drawing shows the classic mechanism of injury: fixed tibia, internal femoral rotation, and quadriceps contraction. (b) Drawing demonstrates transient lateral dislocation of the patella, which results in impaction of the medial patellar facet against the lateral femoral condyle. The crosshatched regions reveal the typical areas of bone contusion involving the inferomedial patella and the anterolateral femoral condyle. The distraction forces frequently cause disruption (arrow) or stretching of the medial retinaculum and the MPFL. The dislocation is usually transient, with the patella spontaneously returning to its normal anatomic position. In many instances, the patient may be unaware of the transient dislocation, and the typical bone marrow edema pattern seen at MR imaging may be the first indication of the true nature of the injury.

The classic bone contusion pattern seen after lateral patellar dislocation includes involvement of the anterolateral aspect of the lateral femoral condyle and the inferomedial aspect of the patella (28,29) (Fig 18). In rare cases, edema may also be seen in the adductor tubercle of the medial femoral condyle secondary to an avulsion injury of the medial patellofemoral ligament (MPFL) (30). The contusion of the lateral femoral condyle after lateral patellar dislocation should be differentiated from the contusion pattern involving the lateral femoral condyle after a pivot shift injury. With lateral patellar dislocation, edema of the lateral femoral condyle is located more anteriorly and peripherally, whereas

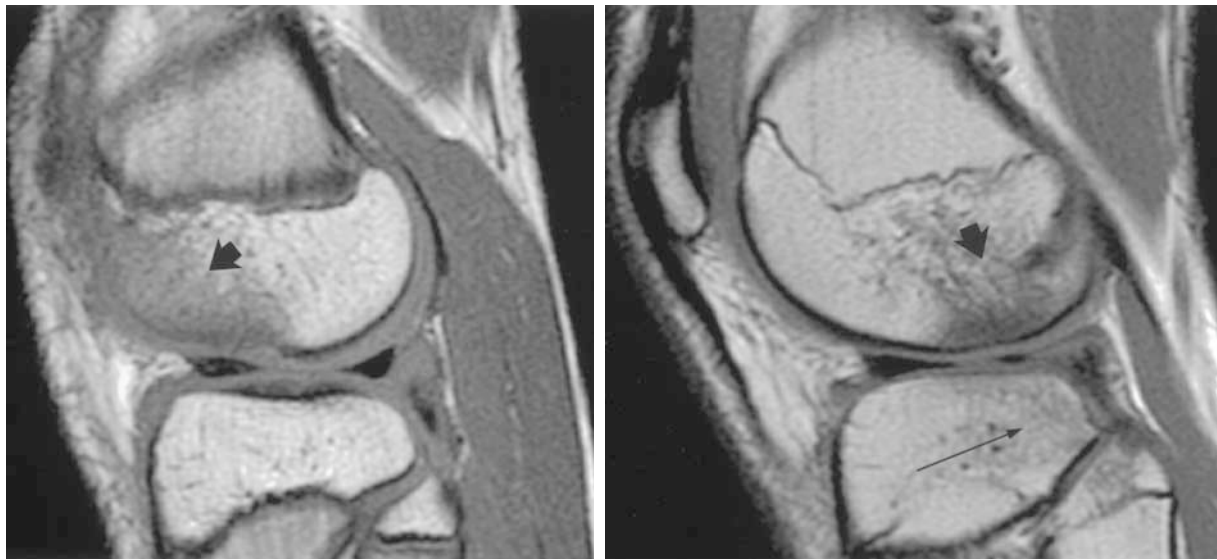
**Figure 19.** Differentiation of lateral femoral condyle edema seen after lateral patellar dislocation from that seen after pivot shift injury. **(a)** On a sagittal T1-weighted SE MR image of a 14-year-old girl after lateral patellar dislocation, the edema (arrow) within the lateral femoral condyle is anteriorly and peripherally located. **(b)** Sagittal T1-weighted SE MR image of a 15-year-old boy after pivot shift injury shows that the edema (short arrow) within the lateral femoral condyle is located more posteriorly. Note also the edema (long arrow) within the posterior lateral tibial plateau.

with pivot shift injury the contusion is more centrally or posteriorly located on the lateral femoral condyle (Fig 19). As stated earlier, the exact location of the femoral edema after a pivot shift injury depends on the degree of flexion of the knee at injury. With less flexion, the femoral edema will be located more anteriorly, but it will be associated with edema of the posterior tibial plateau rather than with edema of the inferomedial patella.

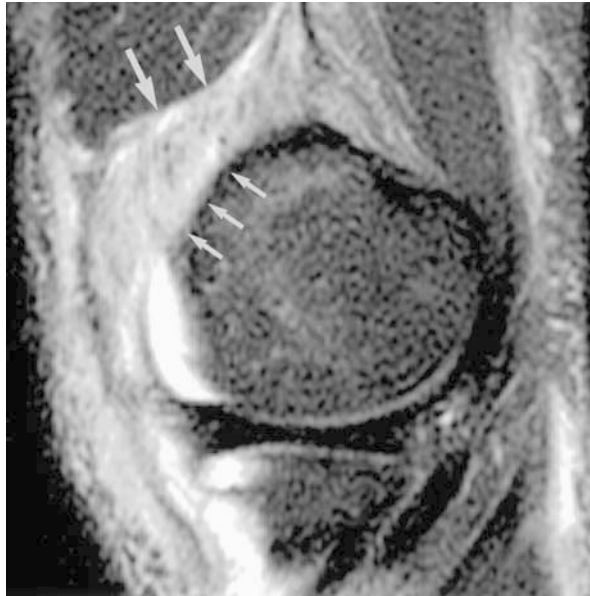
22a.

**Figures 22, 23.** (22) Elevation of the vastus medialis obliquus muscle after lateral patellar dislocation. (a) Sagittal T2-weighted fast SE MR image obtained with fat saturation in a 60-year-old man depicts elevation of the vastus medialis obliquus muscle (long arrows) away from its normal location on top of the medial femoral condyle (short arrows). Extensive edema and hemorrhage are present between the vastus medialis obliquus muscle and the medial femoral condyle. (b) Sagittal T2-weighted fast SE MR image obtained with fat saturation in a 17-year-old boy also reveals edema resulting in elevation of the MPFL (long arrows) away from the medial femoral condyle (short arrows). (23) Osteochondral injury after lateral patellar dislocation. Sagittal T2-weighted fast SE MR image of a 29-year-old man reveals an osteochondral defect (long white arrows) involving the anterior aspect of the lateral femoral condyle. Adjacent bone marrow edema (short white arrow) and a large joint effusion (black arrow) are also present.
